Waterbody Information Pack Avon Waterbody

Draft WIP – January 2011

The purpose of this document is to provide an overview and steer for delivery against environmental objectives in the Avon waterbody

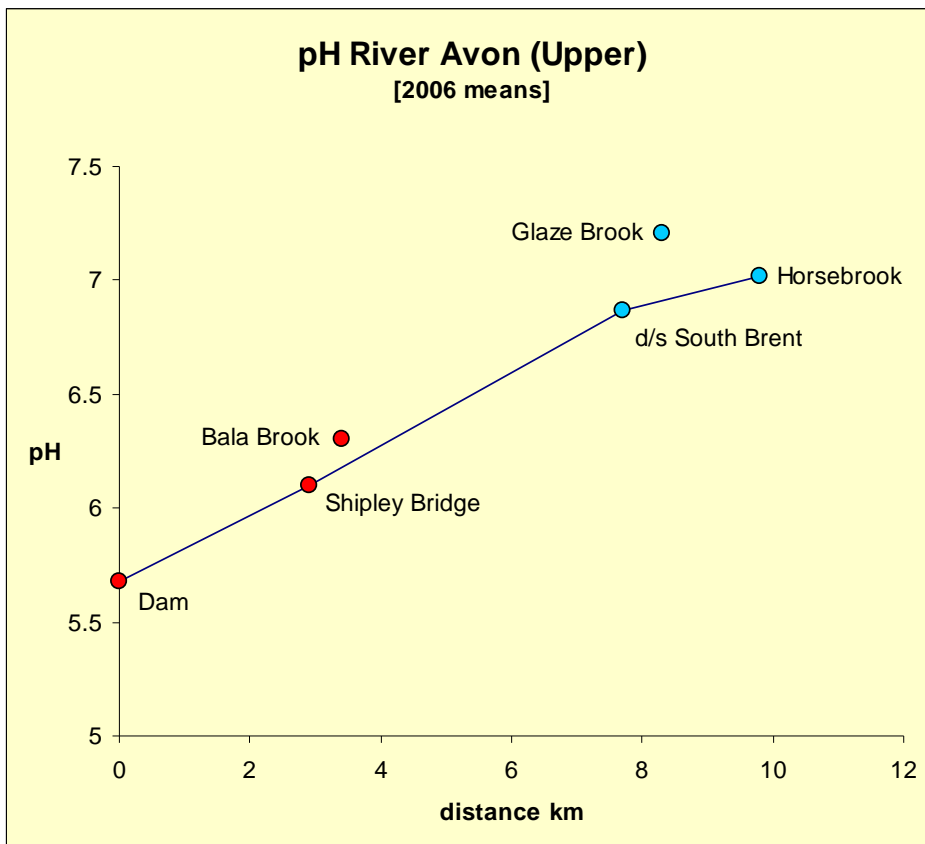
Figure 1. pH increase with distance downstream. Failing sites shown in red. In order to determine whether the pH behaviour shown in Figure 1 is a temporary or persistent feature, mean values for the period 1996-2010 were compared. Figure 2

Teign) is well known). pH values are lowest at the top of the catchment and increase with distance downstream. The 'failing' sites are the three highest up the catchment. This is demonstrated in Figure 1, which shows mean pH values for the year 2006 with distance downstream from Avon Dam.

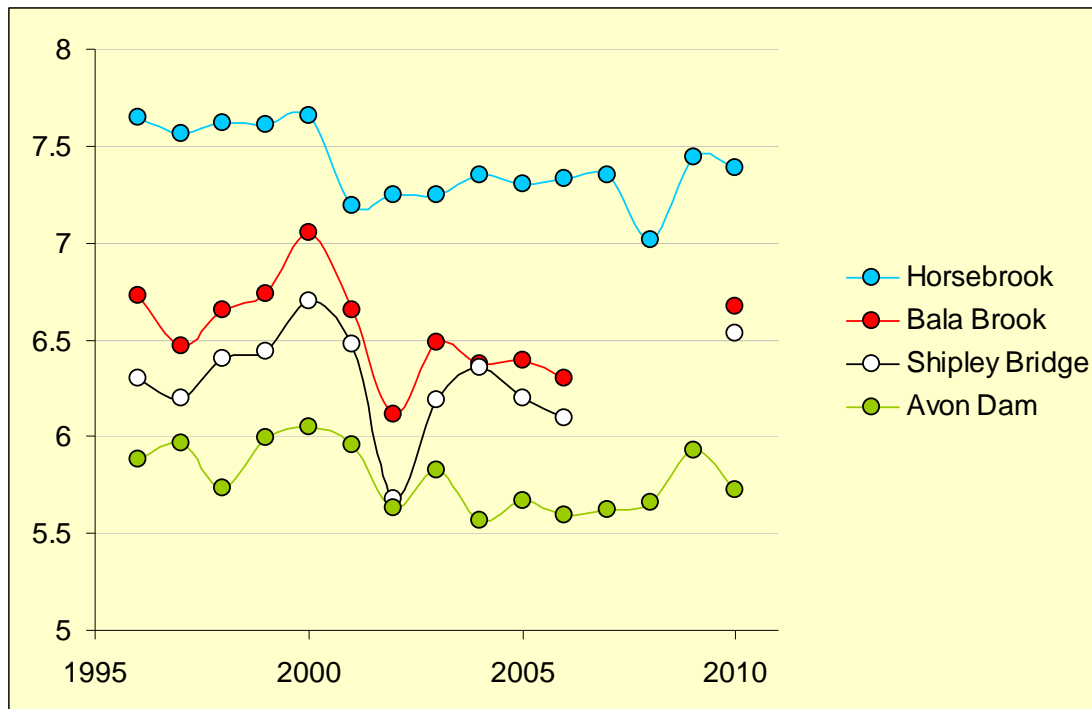
Figure 2. Historic pH profiles (annual means) for the three failing sites and for the downstream site at Horsebrook

shows this data for the three failing sites and for the site at Horsebrook. It is clear that the pH profiles for each site are different and that this difference is permanent. The low pH values for the classification year, therefore, are not an aberration.
